SECTION IV - ASSESSMENT OF EXISTING ARCHITECTURAL CONDITIONS & RECOMMENDED REPAIR WORK

Preservation Plan

First Unitarian Society of Plainfield

724 Park Avenue
Plainfield, New Jersey 07060

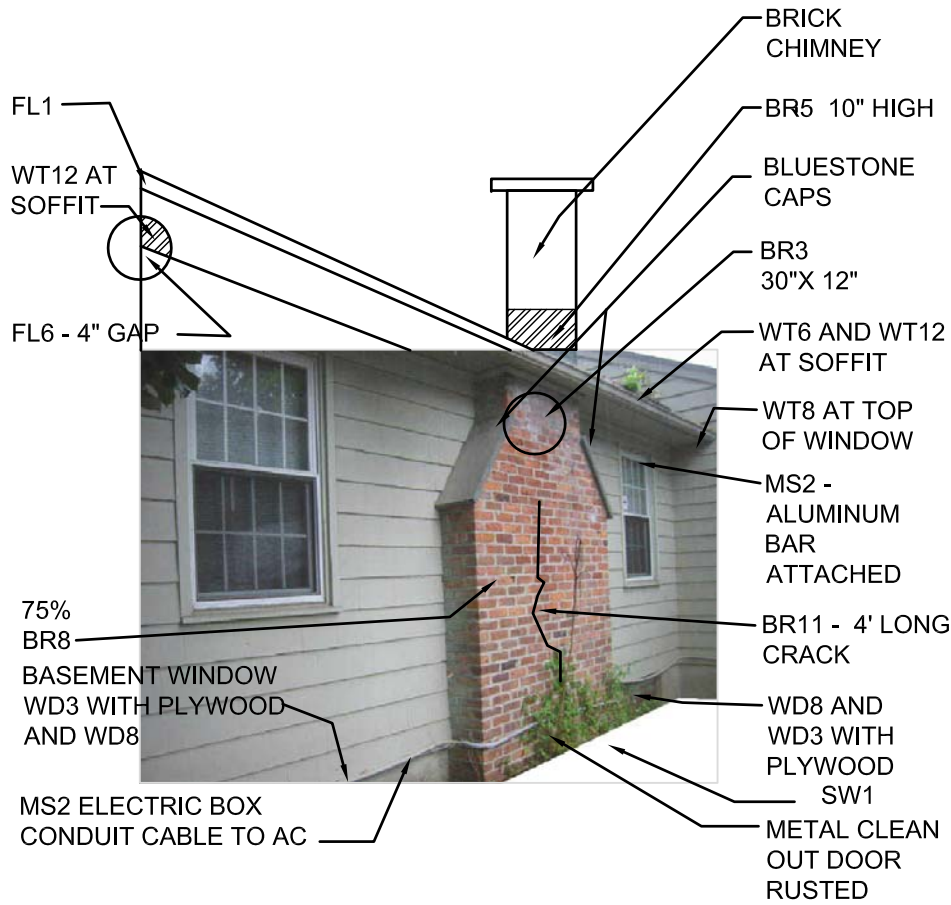
2 WEST ELEVATION
A-4.04 STEVENS WING-STEVENS ROOM

NOTES:
FL1 - CLEANOUT, UNBLOCK AND REPAIR OR REPLACE ALL GUTTERS AND DOWNSPOUTS (100%)
SW4 AND SW5 - THE GRADE ALONG THE EAST SIDE OF THE STEVENS WING HAS SEVERE PROBLEMS WITH DRAINAGE AND PLANT GROWTH. REMOVE ALL PLANT MATERIAL AND REGRADE AREA (100%).
ROOFS - REFER TO DRAWING A-4.20 FOR ROOF CONDITIONS

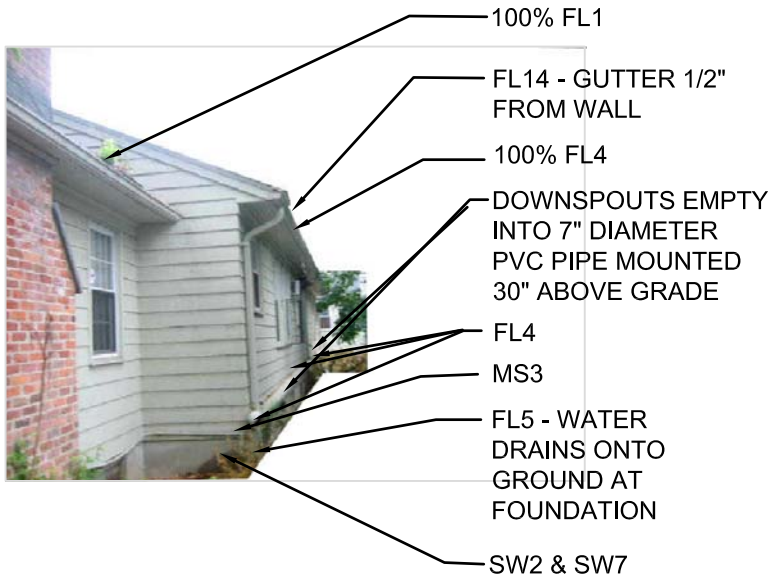
1 WEST ELEVATION - STEVENS WING AND STEVENS ROOM
A-4.05

NOTES:
SW4 THROUGHOUT THIS ENTIRE AREA . REMOVE PLANT MATERIAL, ROOTS, STUMPS AND DEBRIS AND REGRADE AREA. (100%).
FL1 -CLEANOUT, UNBLOCK AND REPAIR OR REPLACE ALL GUTTERS AND DOWNSPOUTS (100%)
FOR ROOF NOTES SEE DRAWING A-4.20.

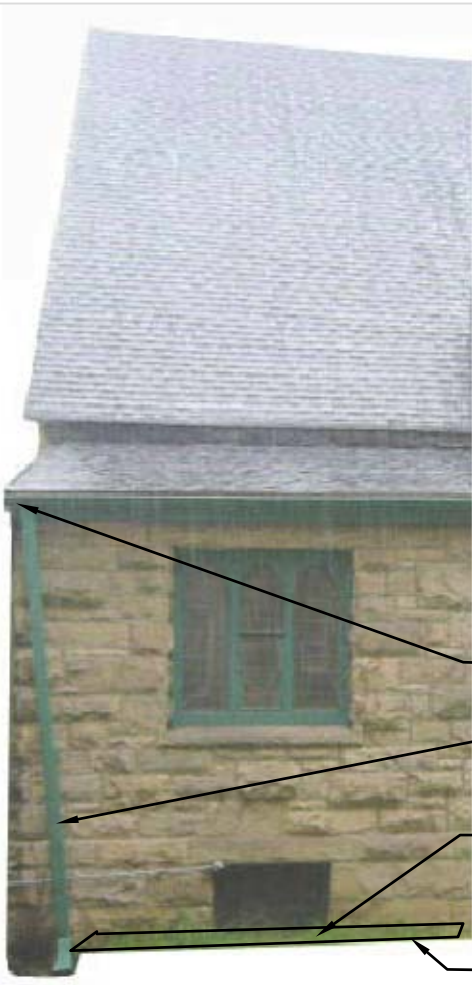
1 NORTH ELEVATION-WEST CHURCH
A-4.09

R2
FL13
MR3
ST1 - BRIGHT GREEN POWDERY SUBSTANCE

NOTES:
MR2 - REPOINT ALL STONework (100%)
FL1 - CLEANOUT, UNBLOCK AND REPAIR OR REPLACE ALL GUTTERS AND DOWNSPOUTS (100%)
ST9 - PREVENT FURTHER DETERIORATION OF MINOR CRACKED STONE BY FILLING WITH GROUT (20%)
ROOFS - REFER TO DRAWING A-4.20 FOR ROOF CONDITIONS

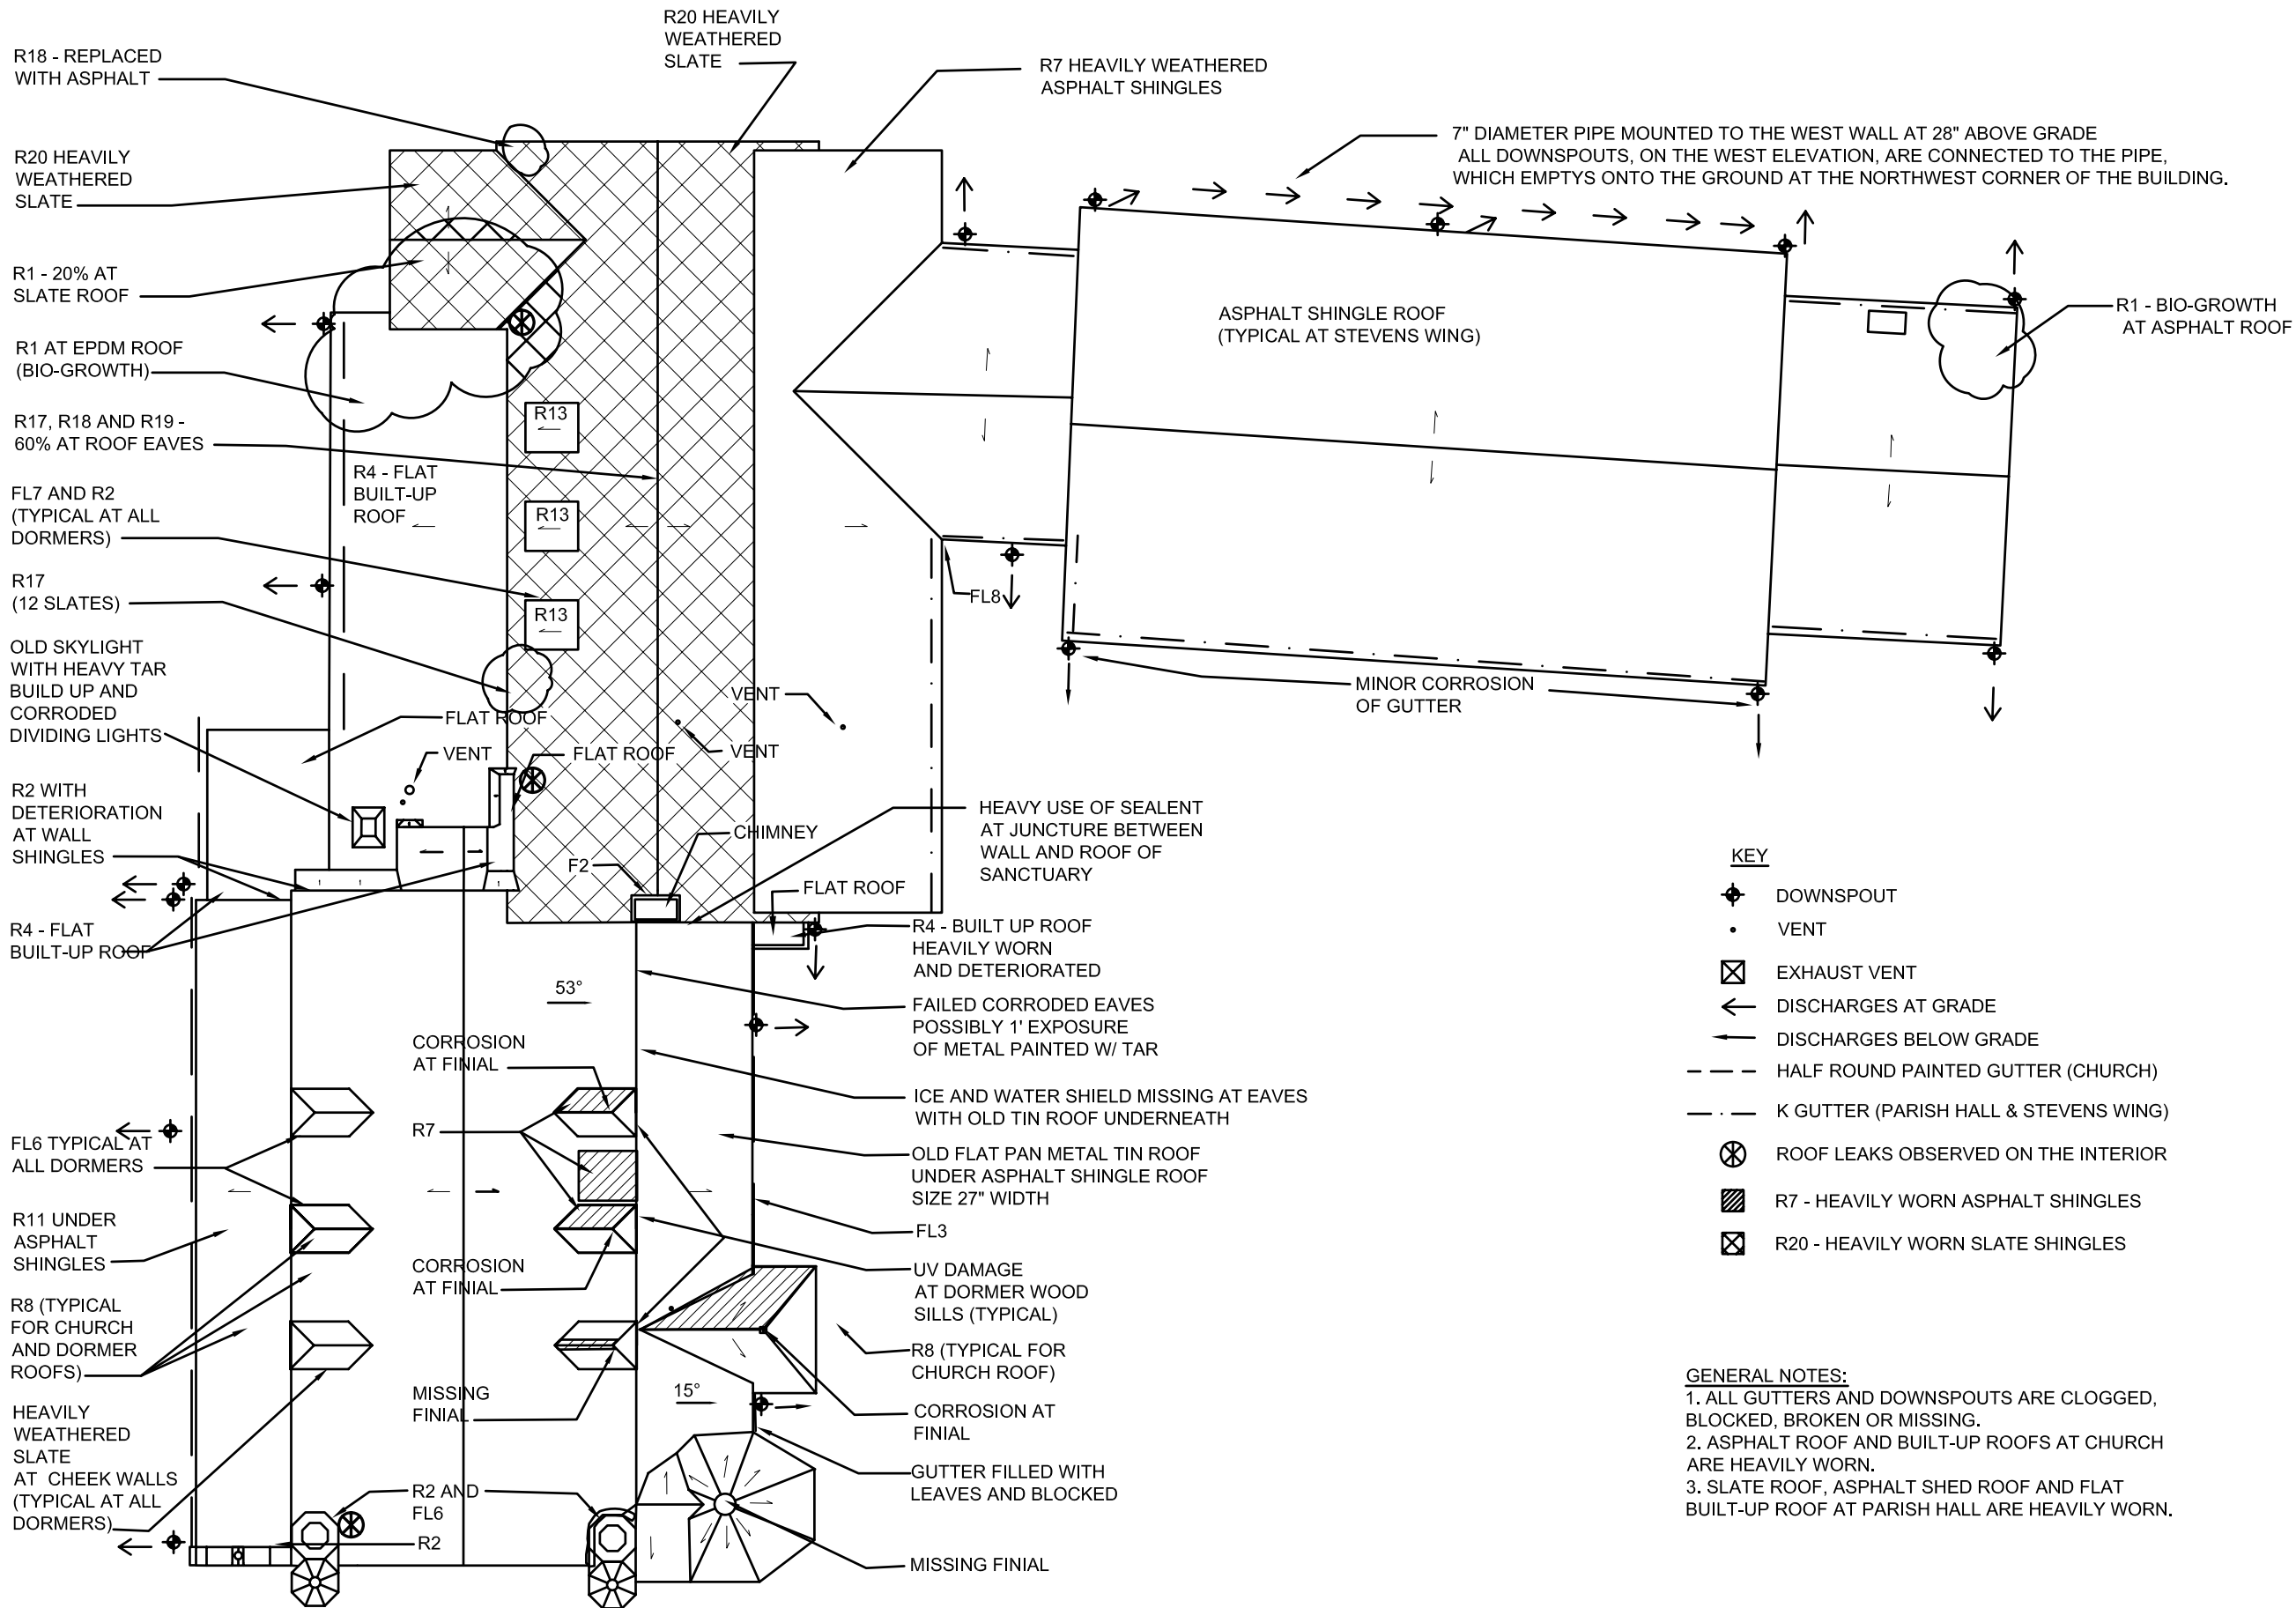
GENERAL NOTES:
 1. ALL GUTTERS AND DOWNSPOUTS ARE CLOGGED, BLOCKED, BROKEN OR MISSING.
 2. ASPHALT ROOF AND BUILT-UP ROOFS AT CHURCH ARE HEAVILY WORN.
 3. SLATE ROOF, ASPHALT SHED ROOF AND FLAT BUILT-UP ROOF AT PARISH HALL ARE HEAVILY WORN.
